SUBJECT: CAFO Inspection,
FOIA Ex. 6
(Personal) Farms, Henry County, Ohio

Concentrated Animal Feeding Operation Inspection Report

Farms, Dairy and Satellite Facilities
New Bavaria, Ohio

Inspected August 16 and 17, 2016

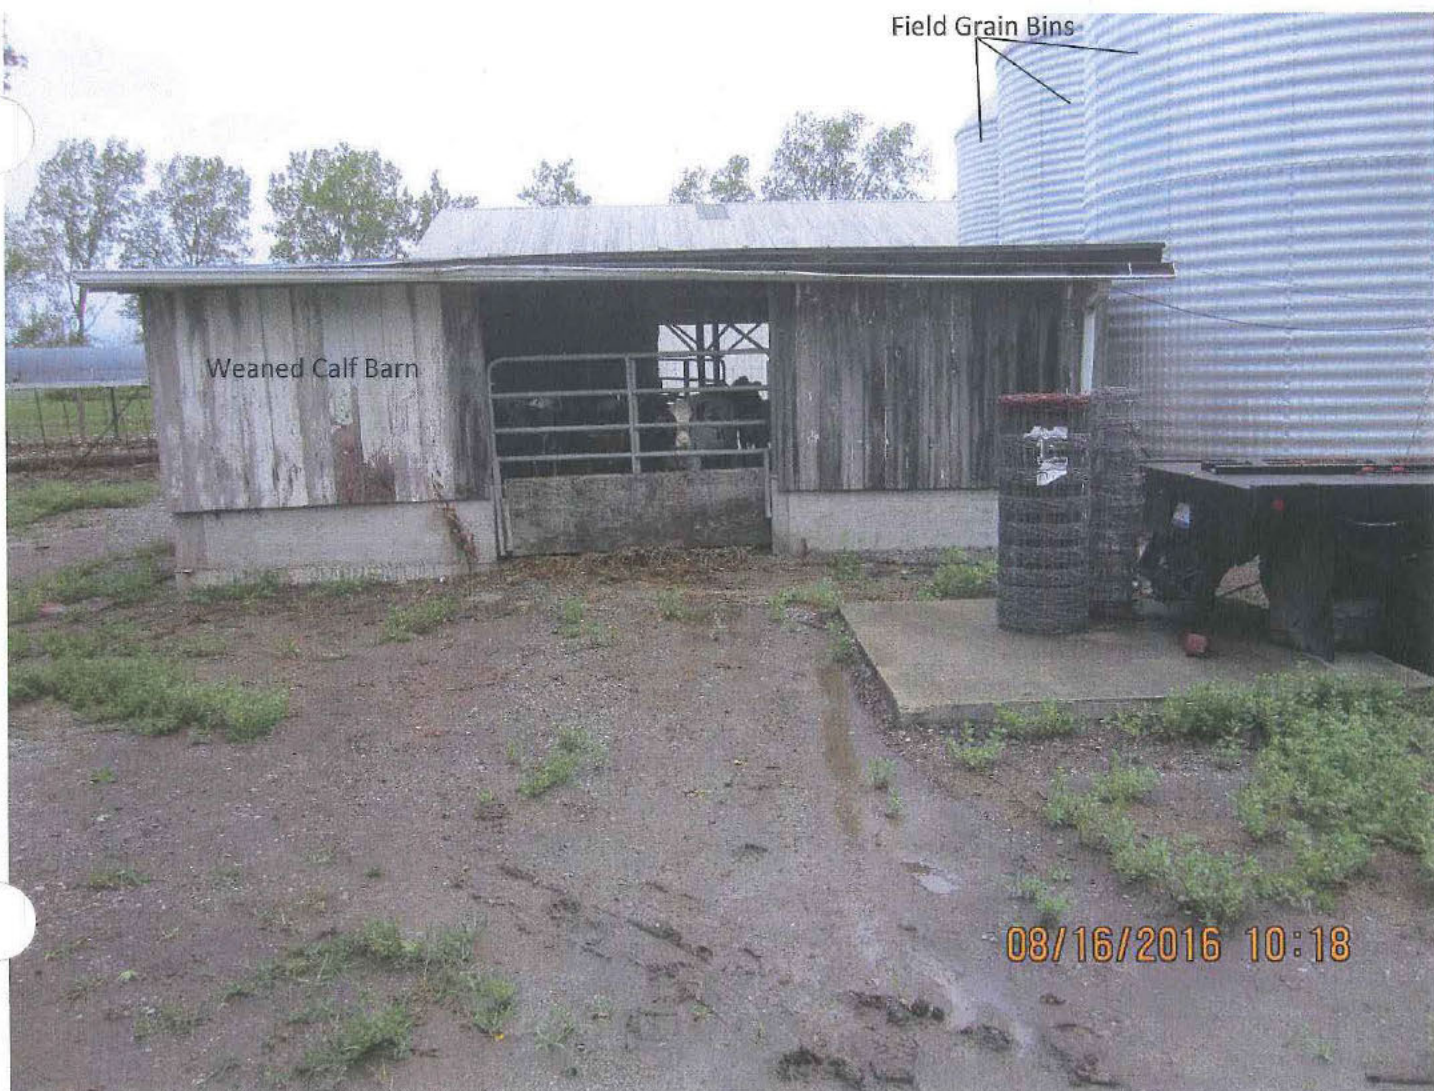
Photograph No. 15 (file IMG_0725)

Straw is used as bedding material in the Calf Barn (Attachment 2, Photograph 18), Weaned Calf Barn (Attachment 2, Photograph 15), the Calving Barn and the Beef Cattle Barn. Straw bedding is removed once every 3 to 4 months with a skid steer. The removed straw bedding is directly land applied if possible or stored on the bare ground in the Solids Storage Area near the northeast outside corner of the Equipment/Hay Storage Barn (Attachment 2, Photographs 11, 19 and 23). Ex. 6. (Personal Privacy) Ex. 6. (Personal Privacy) estimated that the Solids Storage Area has a storage capacity of roughly 3 to 4 months. The Dry Cow/Heifer Barn does not have stalls. The inside of the Dry Cow/Heifer Barn is one large open area for the animals with no bedding used. A manure mat forms on the floor of the Dry Cow/Heifer Barn and this manure mat is removed and land applied as the weather conditions allow. Sand bedding is used in the Freestall Barn (Attachment 2, Photograph 5). A skid steer is used to scrape manure from the lanes between the freestalls twice a day. The stalls are also re-dressed with new sand as necessary. Manure/sand scraped up from these areas with the skid steer is dumped directly into the underground concrete manure storage vault. The concrete corral areas are also manually scraped with a skid steer as needed to remove manure, according to Ex. 6. (Personal Privacy) Manure scraped up from these corral areas is also dumped directly into the concrete manure storage vault (Attachment 2, Photograph 14). Manure is manually pumped out of the north end of the concrete manure storage

Description: The Weaned Calf Barn holds calves that are three to four months old. The gutter on the south side of this smaller barn is in disrepair and gutter run-off falls onto the ground.

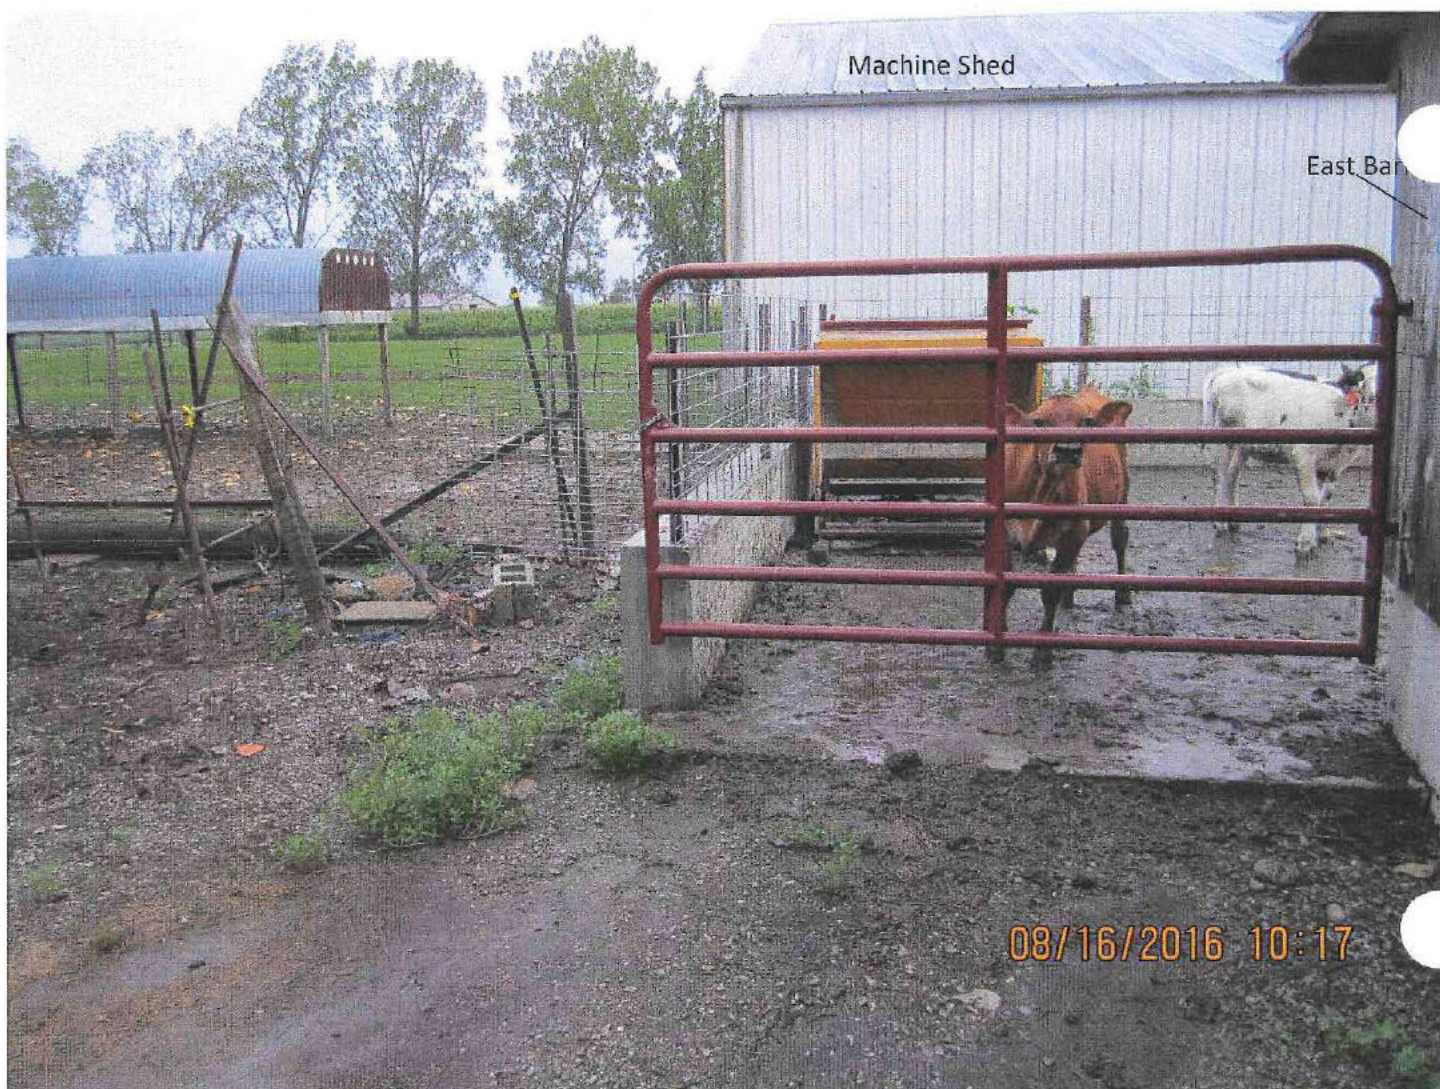
Photograph No. 16 (file IMG_0723)

Description: View of the concrete corral on the north side of the Weaned Calf Barn. There is a fenced grass and dirt pasture area to the west side of the corral which is used for the weaned calves. A concrete knee wall forms the perimeter around the corral area and prevents storm water run-off from leaving the corral. The section of concrete at this gated entrance to the corral is sloped towards the corral to prevent storm water run-off from leaving the corral area.

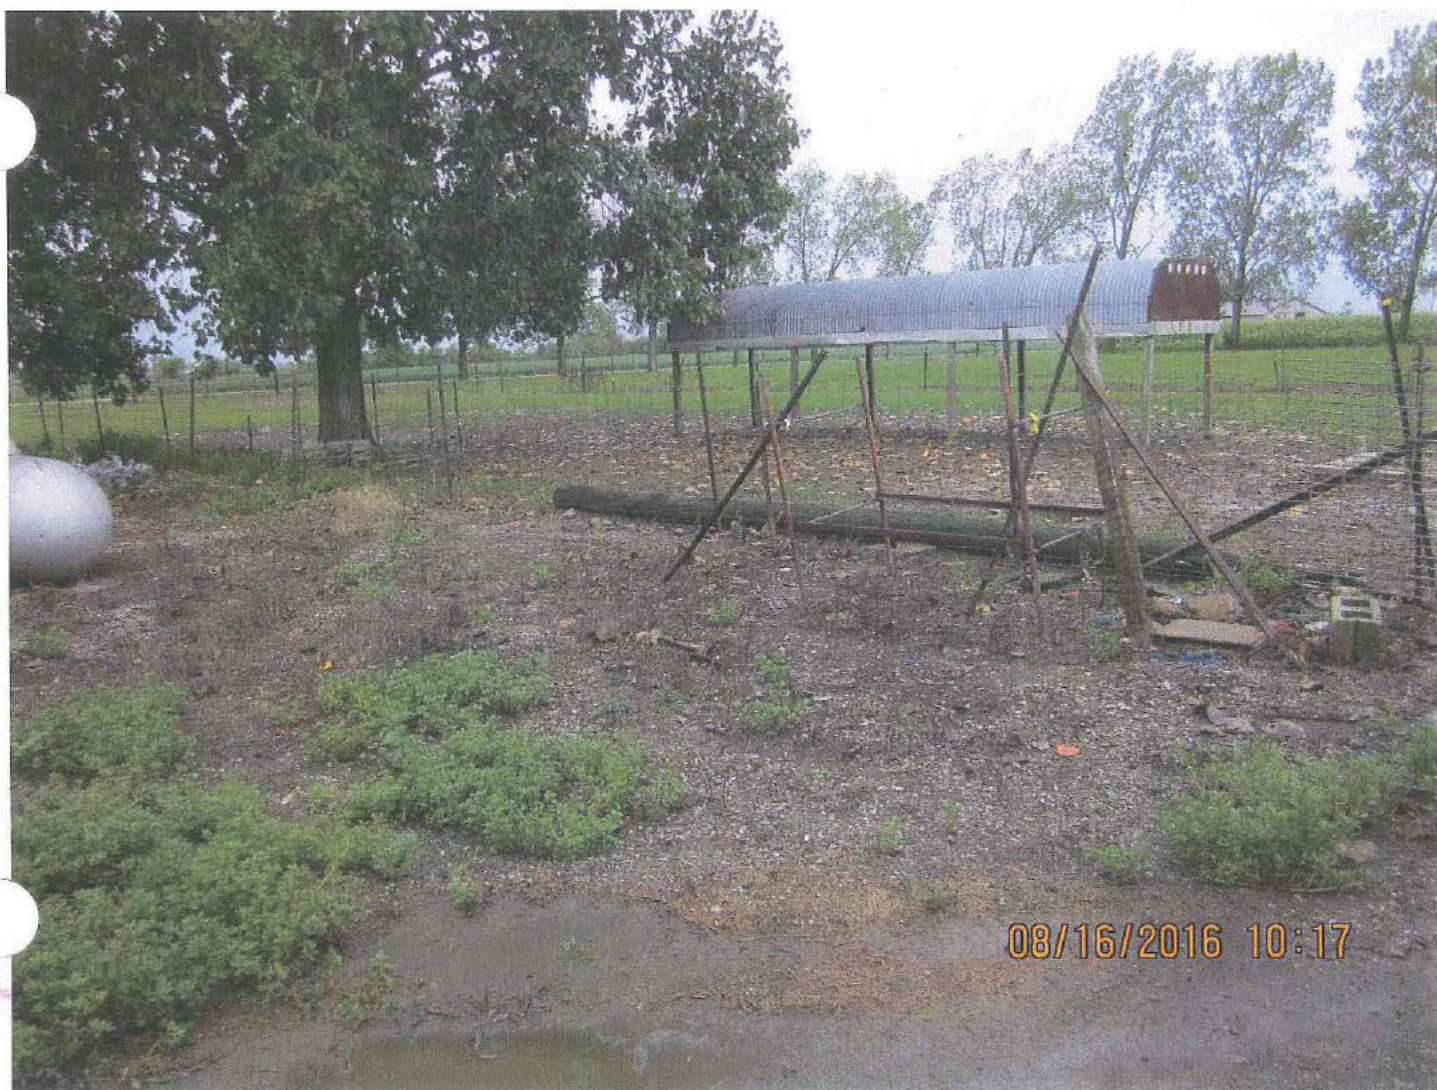
Photograph No. 17 (file IMG_0724)

Description: View of the south fence of the fenced grass and dirt pasture area to the west side of the Weaned Calf Barn. This pasture area is used for the weaned calves. The partial elevated metal roof provides shade for the calves.

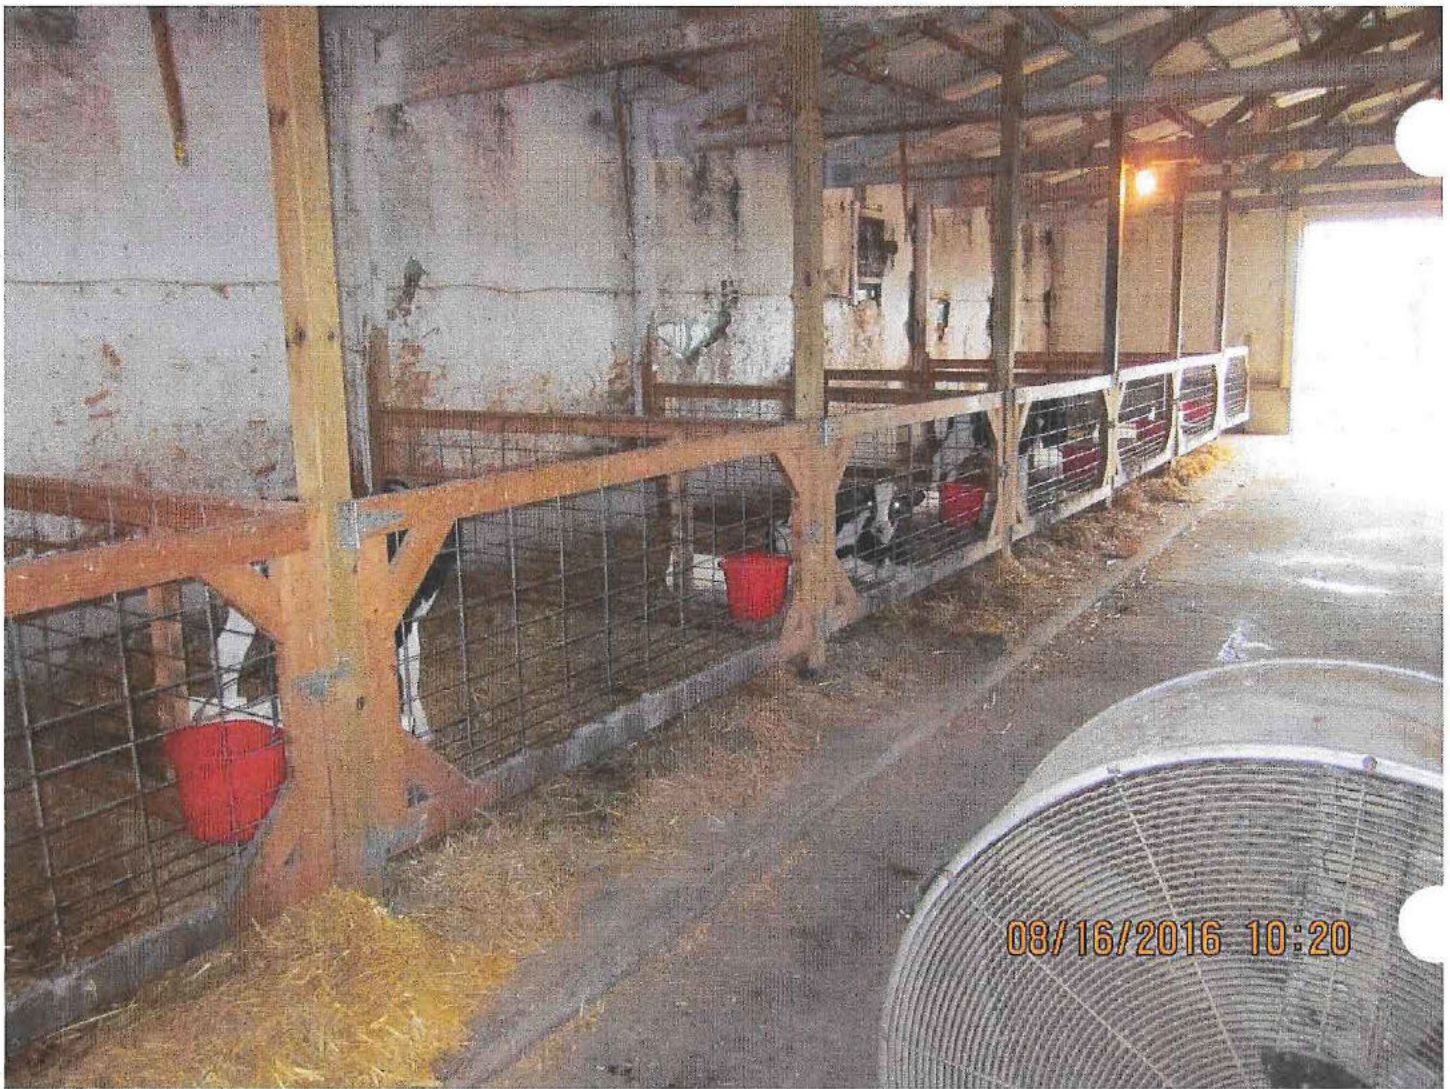
Photograph No. 18 (file IMG_0726)

Description: The Calf Barn has individual calf pens with straw bedding. Calves stay in this barn until 3 months old. The east barn door opens into a fenced concrete pad area that wraps around the east and south sides of the Calf Barn.

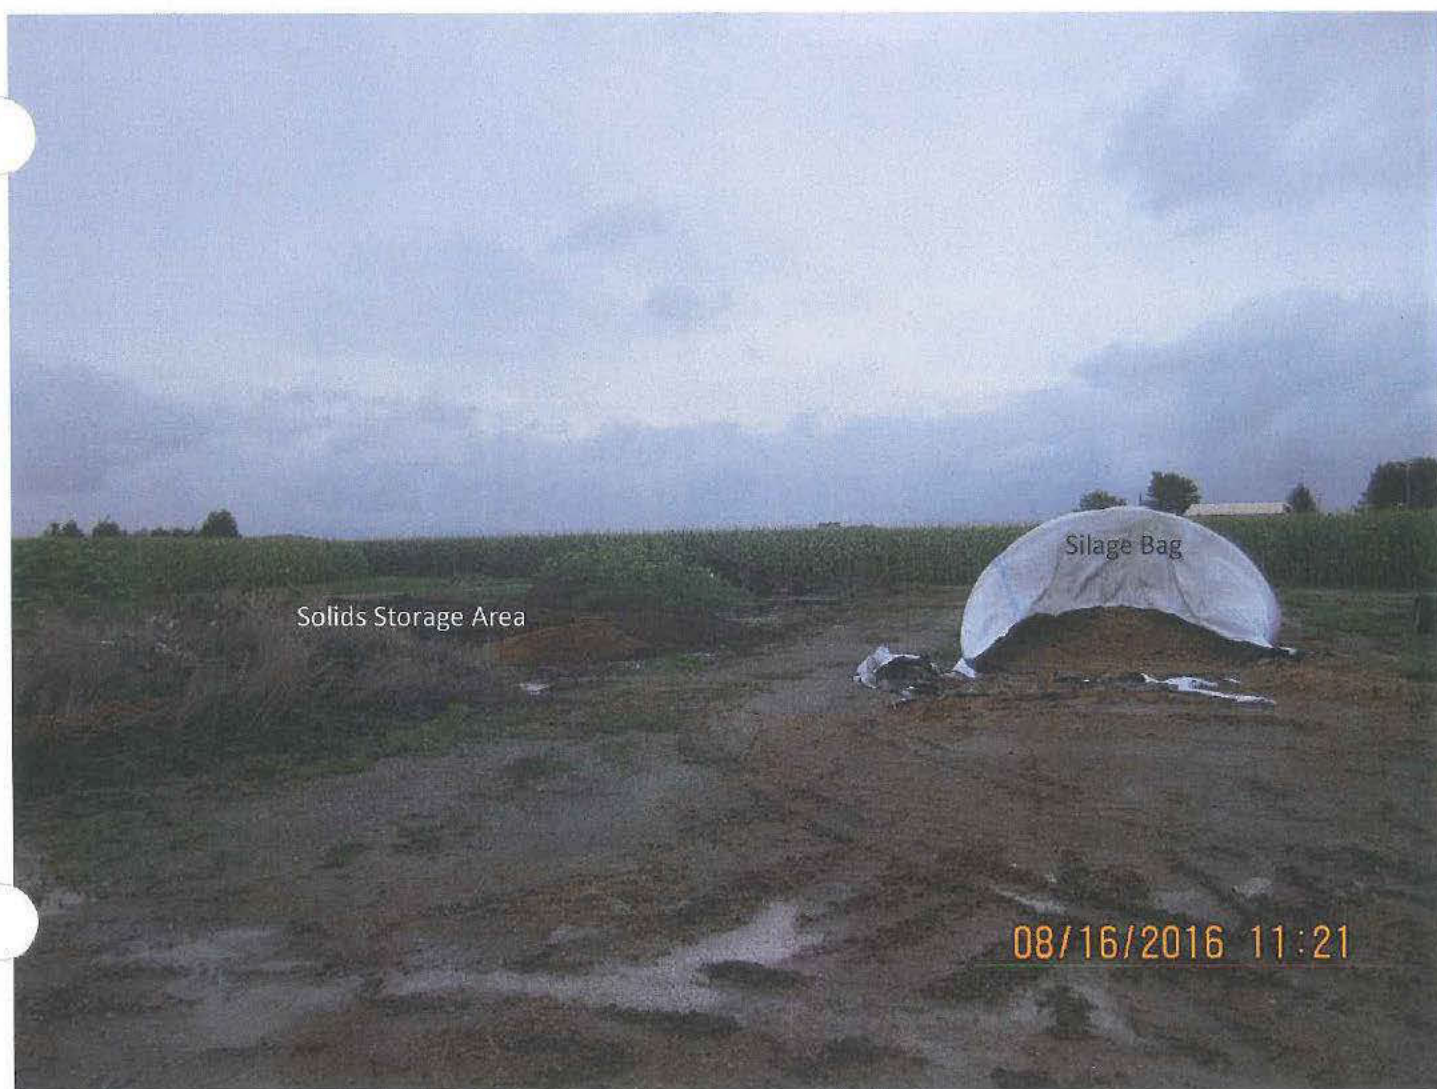
Photograph No. 19 (file IMG_0727)

Description: View of the open end of the silage bag currently in use. Due to the slope of the ground surface, storm water run-off flows towards the Solids Storage Area which drains north into the constructed drainage trench, according to Ex. 6 (Personal Privacy)

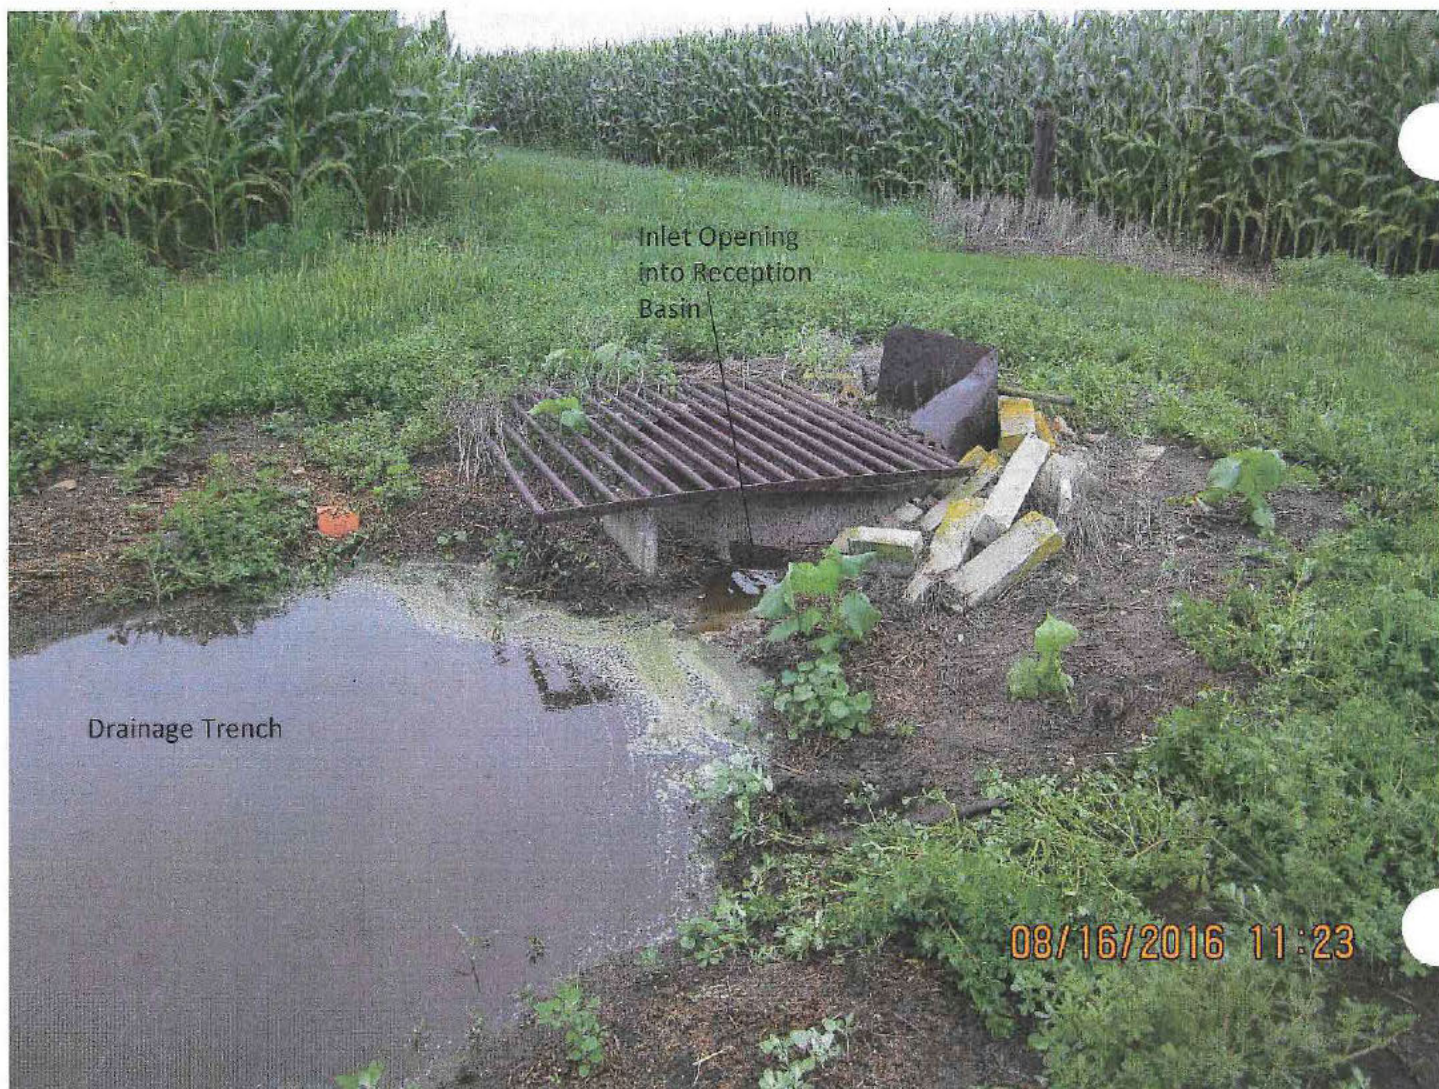
Photograph No. 20 (file IMG_0728)

Description: View of the drainage trench inlet into the steel reception basin where sample S01 was collected. The sample was collected from the inlet opening from the inside of the basin wall as flow entered the basin.

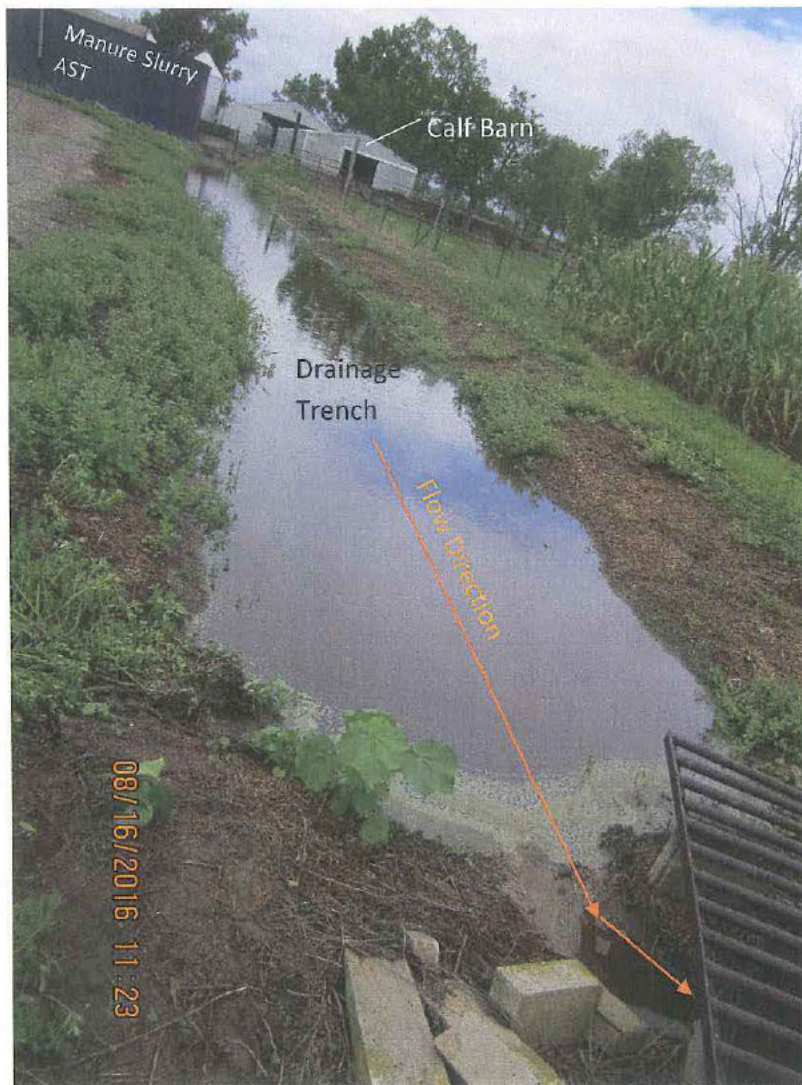
Photograph No. 21 (file IMG_0729)

Description: View looking at the constructed drainage trench which flows into the steel reception basin. Storm water run-off from the concrete corral areas on the east sides of the Dry Cow/Heifer Barn, Freestall Barn, Calving Barn and Milking Parlor; as well as the east and south sides of the Calf Barn, flows to a central drainage point adjacent to the north side of the Manure Slurry AST. This drainage point directs run-off flow into the west end of the constructed drainage trench in the production area.

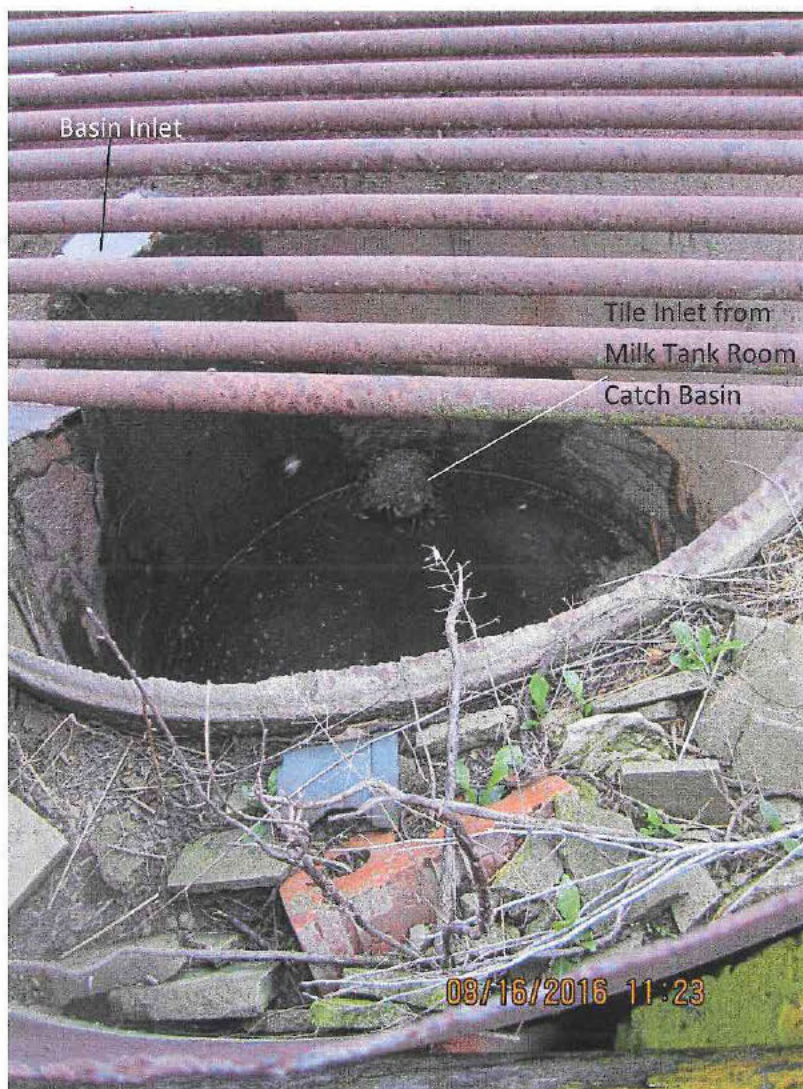
Photograph No. 22 (file IMG_0730)

Description: View of the inlet into the steel reception basin from the drainage trench and the tile inlet from the catch basin outside the north wall of the Milk Tank Room. Milk Tank rinse water flows into floor drains in the Milk Tank Room which are plumbed to the exterior catch basin. A tile directs flow from the exterior catch basin to the reception basin as seen in this photograph.

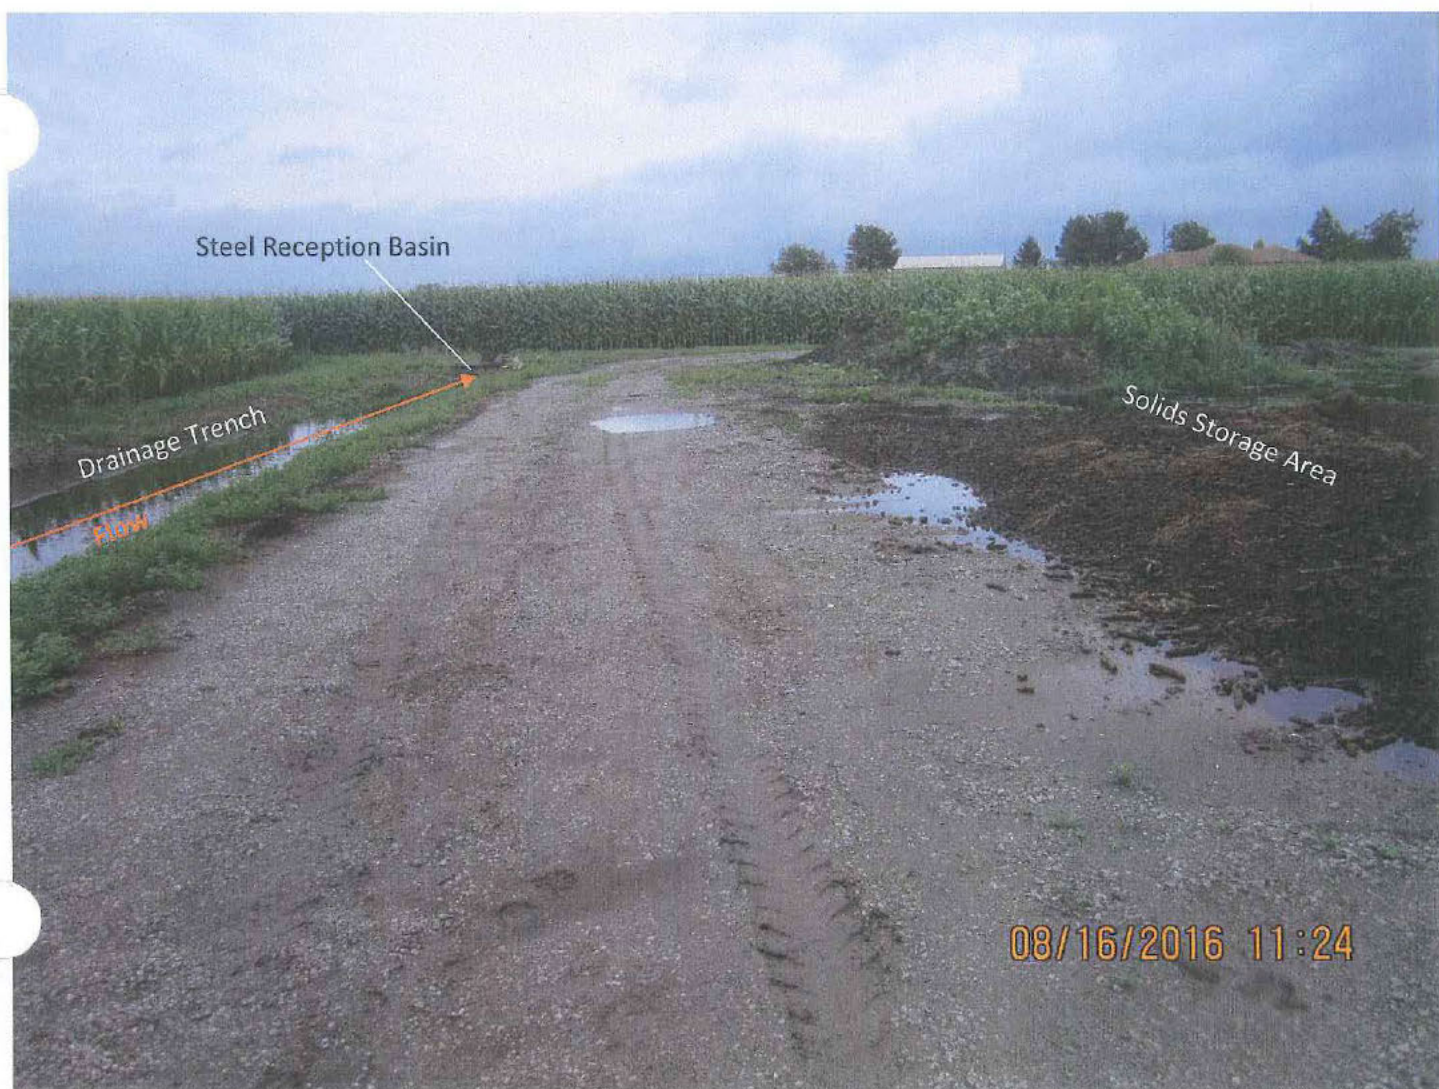
Photograph No. 23 (file IMG_0731)

Description: View of the Solids Storage Area, the constructed drainage trench and the steel Reception Basin that receives the drainage trench flow.

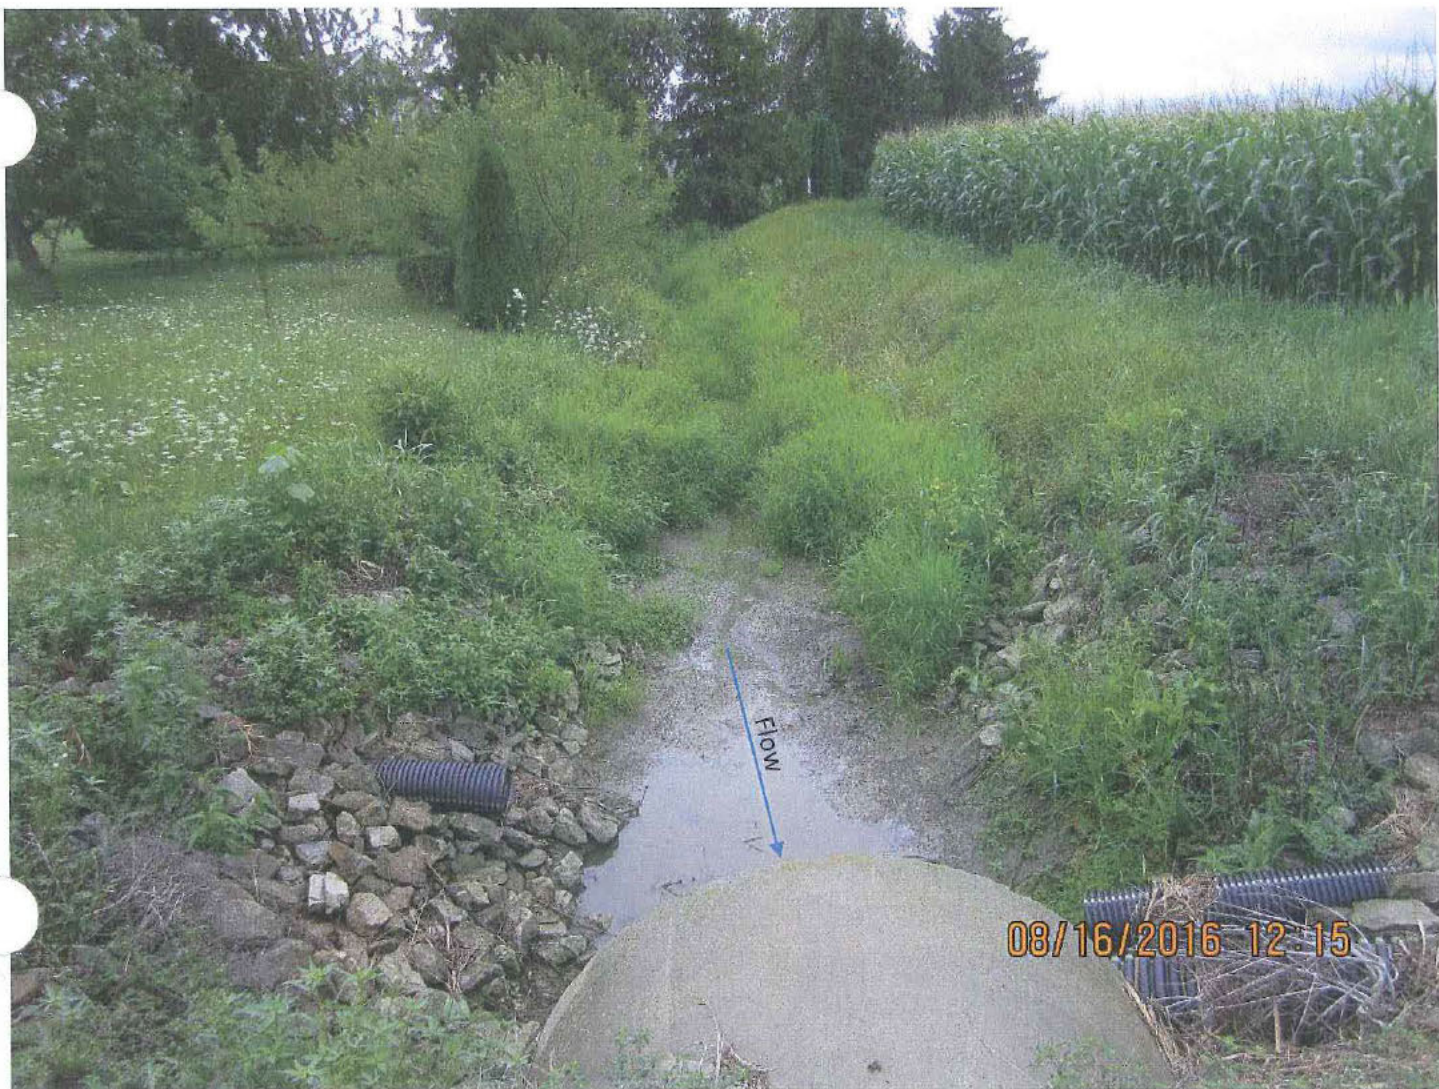
Photograph No. 25 (file IMG_0733)

Description: The first accessible point on the unnamed tributary waterway downstream from the FOIA Ex. 6 Farm
(Personal) Satellite Facility is at the roadway crossing on Township Road B. This unnamed tributary receives contaminated storm water run-off from a reception basin for the corral area at the Satellite Facility. This view is looking upstream from the roadway crossing on Township Road B.

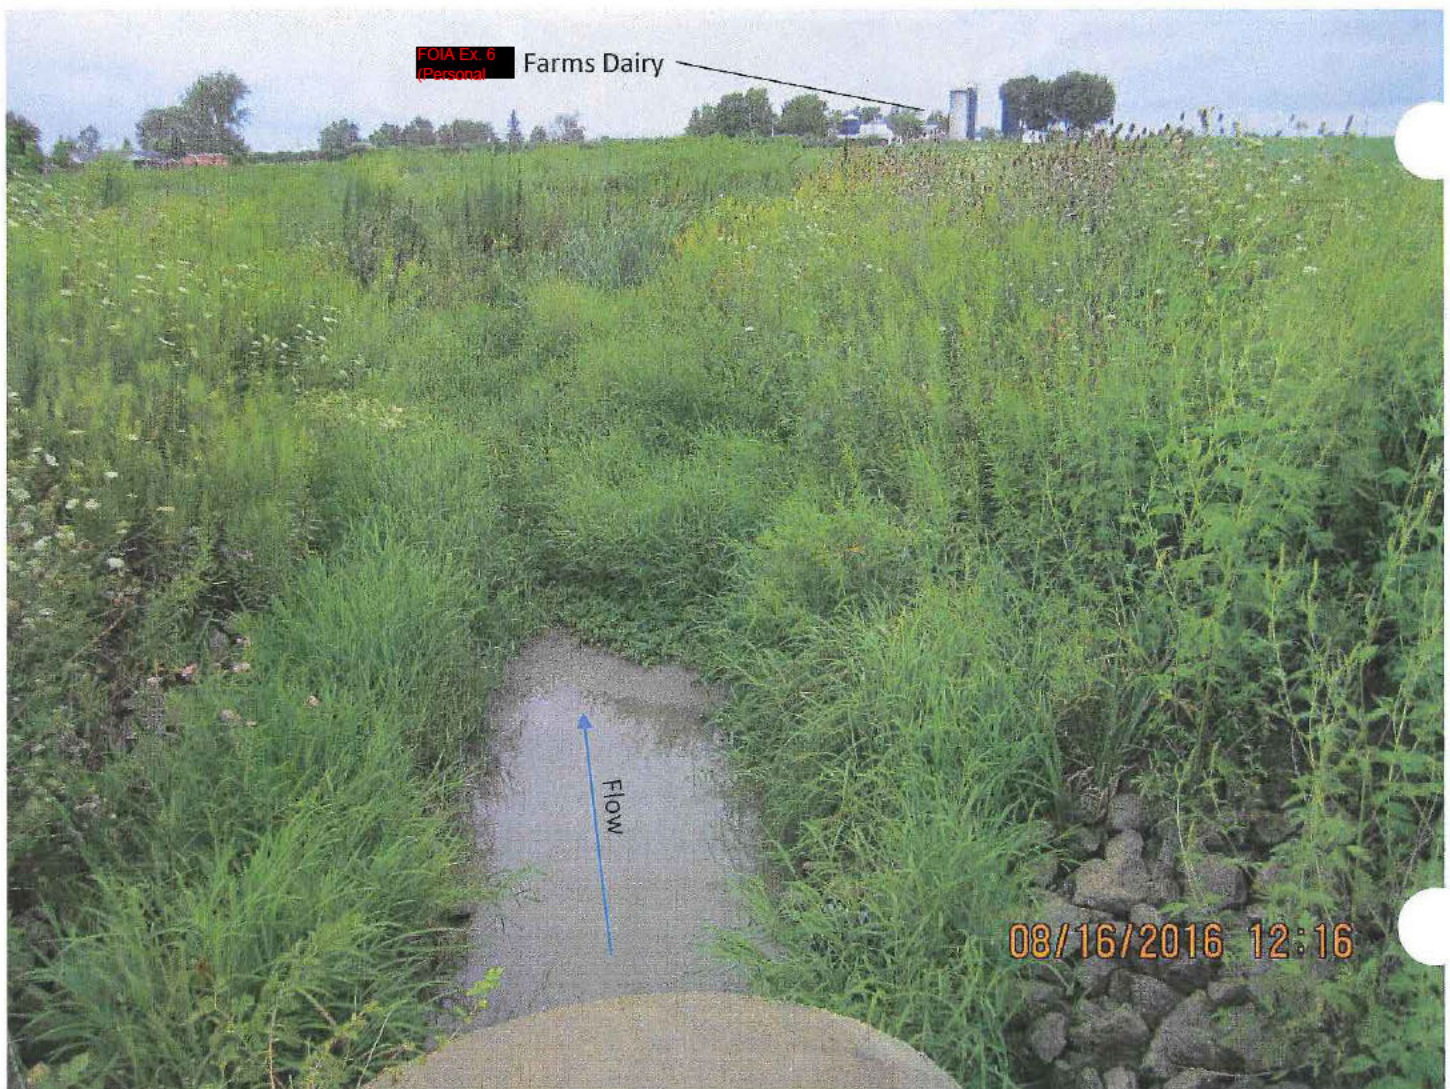
Photograph No. 26 (file IMG_0734)

Description: The first accessible point on the unnamed tributary waterway downstream from the FOIA Ex. 6 (Personal) Farms Satellite Facility is at the roadway crossing on Township Road B. This unnamed tributary receives contaminated storm water run-off from a reception basin for the corral area at the Satellite Facility. This view is looking downstream from the roadway crossing on Township Road B. The FOIA Ex. 6 (Personal) Farms Dairy is visible in the background.

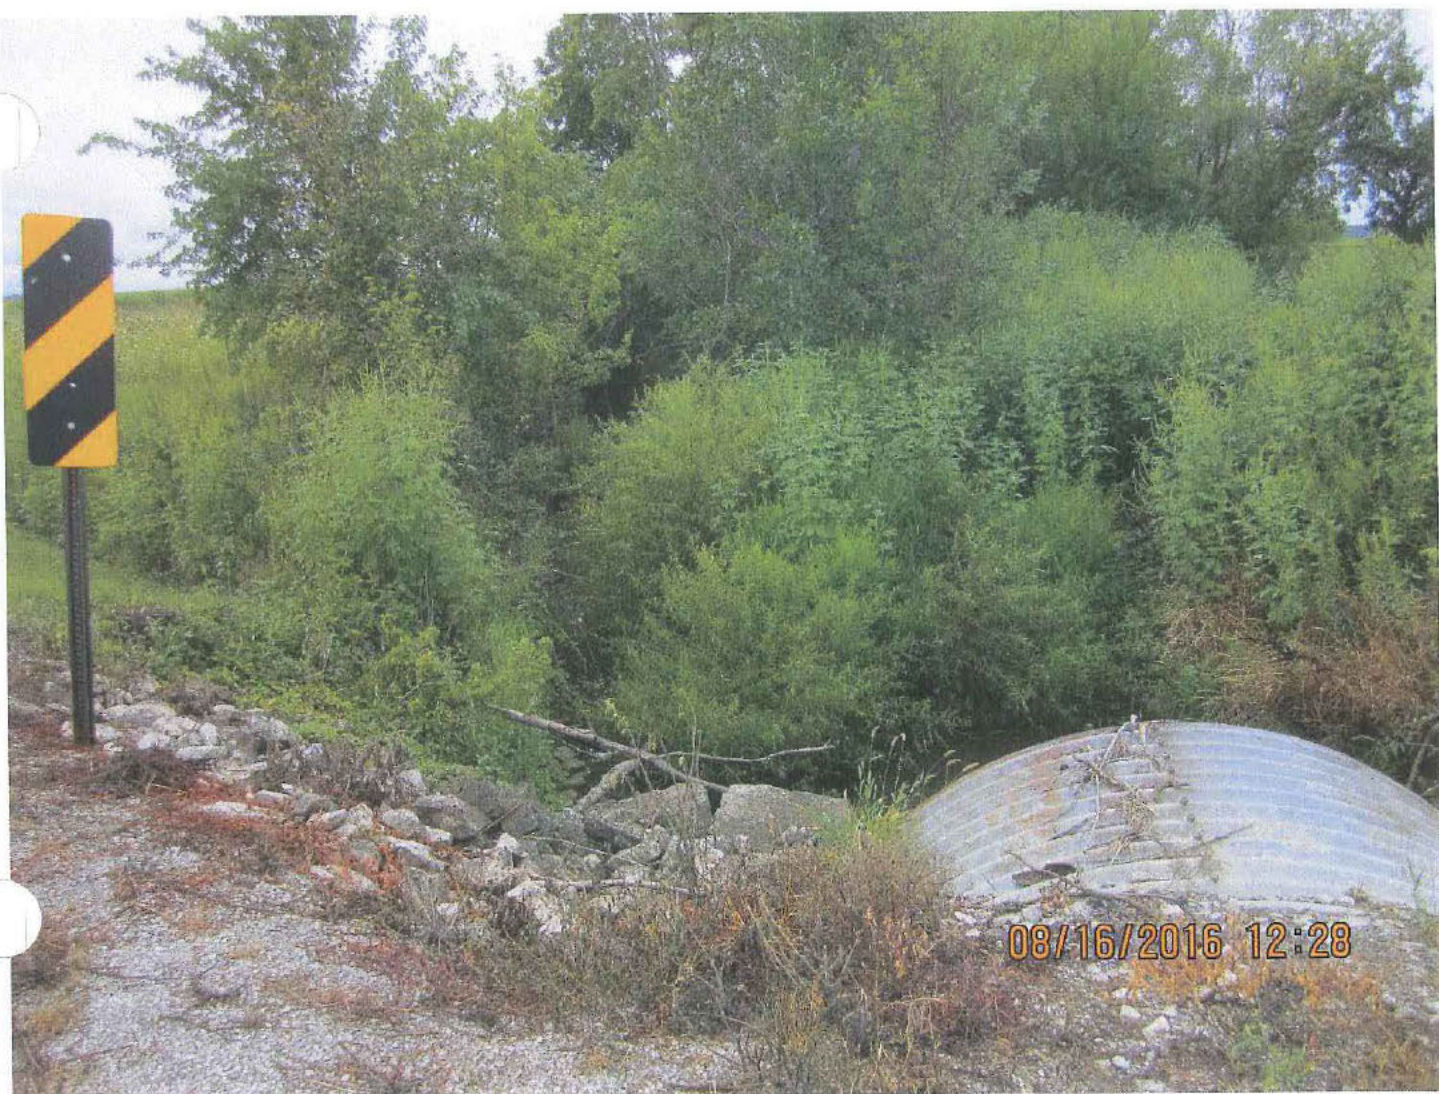
Photograph No. 27 (file IMG_0735)

Description: The first accessible point on Mess Ditch, downstream from the FOIA Ex. 6 Farms Dairy and Satellite Facility is at the roadway crossing on County Road 12. Both unnamed tributaries that receive the discharges from the contaminated storm water reception basins at the dairy and satellite facilities are tributary to Mess Ditch. This view is looking upstream at Mess Ditch from the roadway crossing on County Road 12.

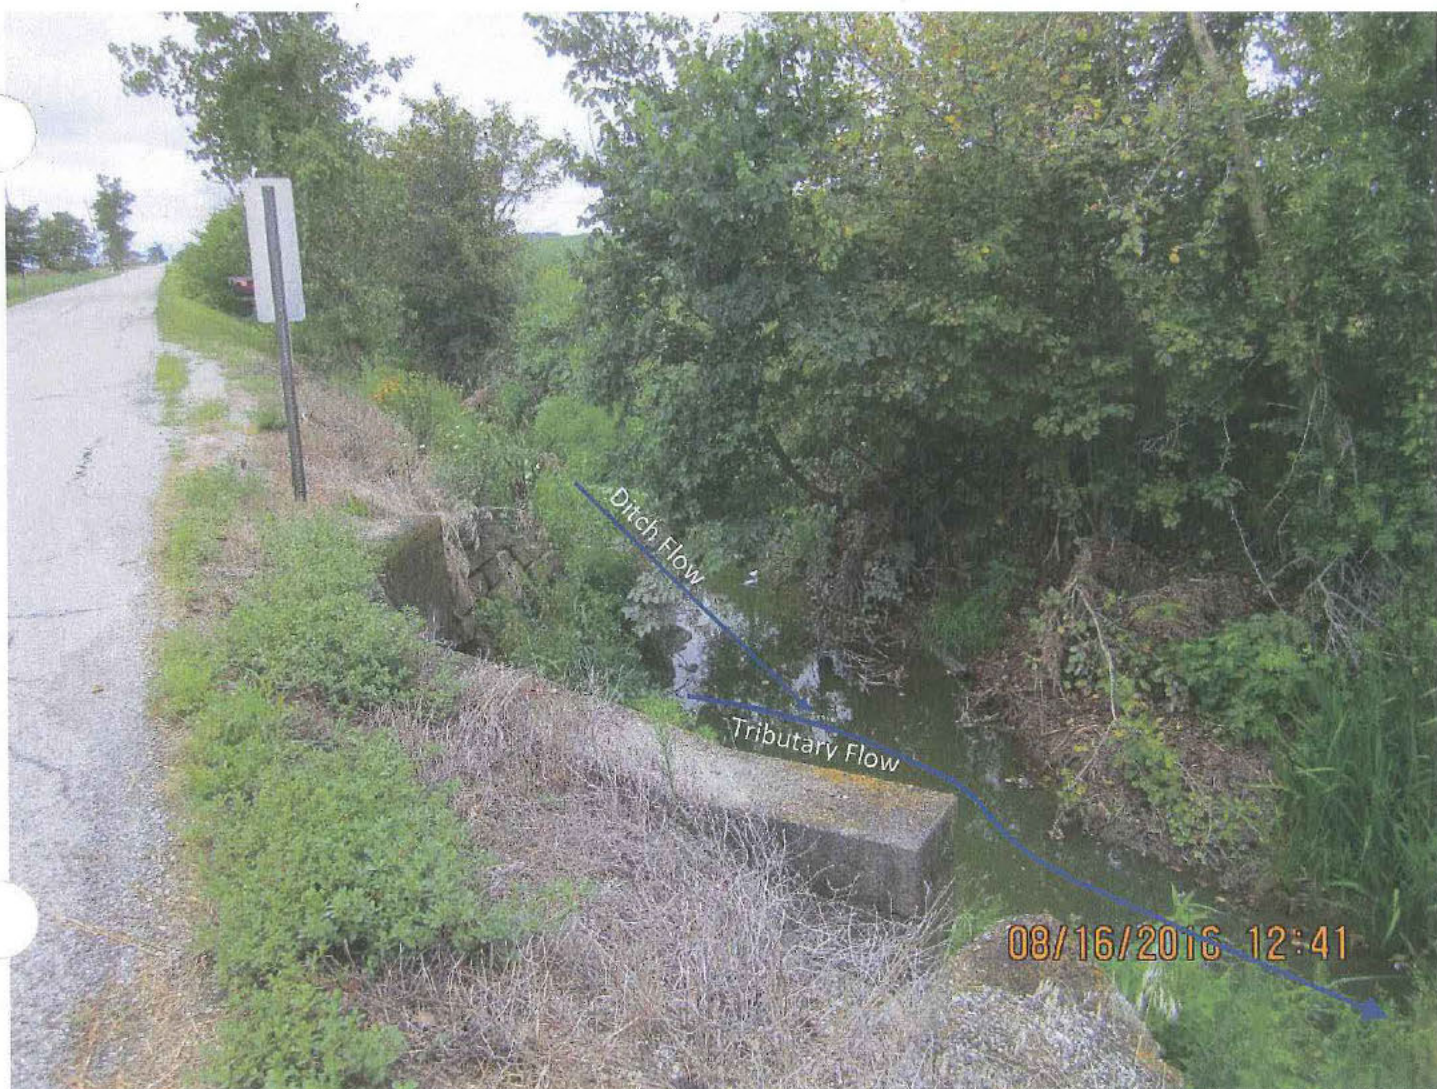
Photograph No. 31 (file IMG_0739)

Description: The next accessible point on the unnamed tributary waterway downstream from the FOIA Ex. 6 Farms Satellite Facility is at the roadway crossing on Township Road 12, just south of the intersection of Township Road 12 and County Road Y. This unnamed tributary receives contaminated storm water run-off from a reception basin for the corral area at the Satellite Facility upstream of this location. At this roadway crossing, on the west side of the road, flow from the unnamed tributary joins with the flow in the roadside ditch and continues to flow northwest into the next unnamed tributary waterway which flows north into Mess Ditch.

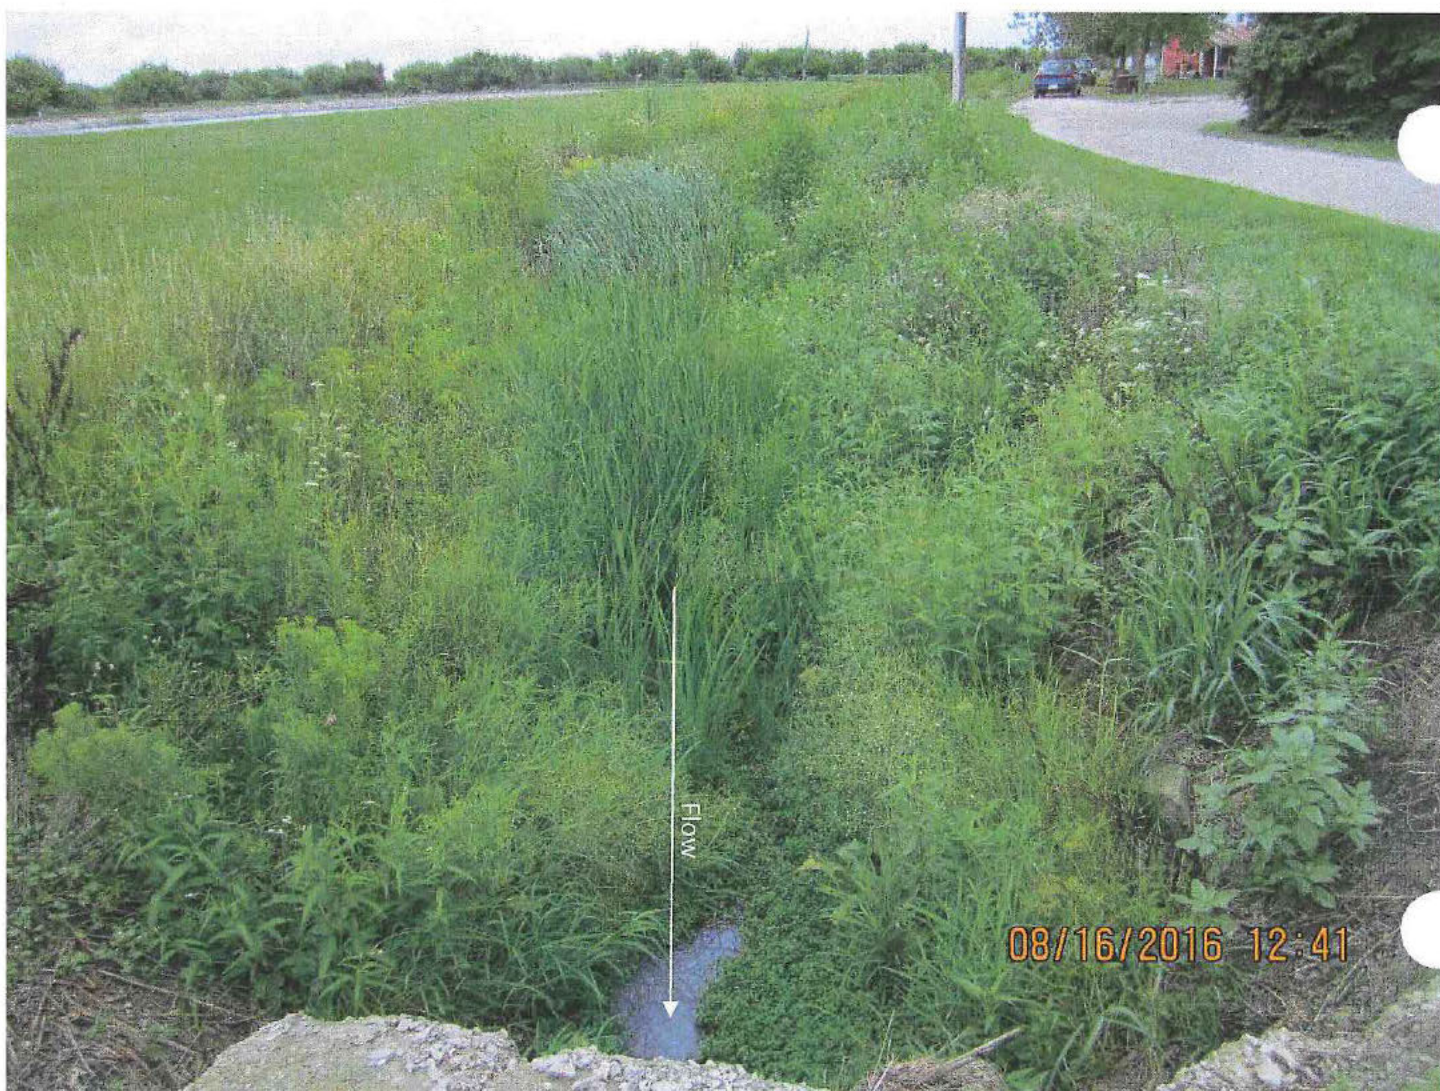
Photograph No. 32 (file IMG_0740)

Description: The next accessible point on the unnamed tributary waterway downstream from the FOIA Ex. 6 (Personal) Farms Satellite Facility is at the roadway crossing on Township Road 12, just south of the intersection of Township Road 12 and County Road Y. This unnamed tributary receives contaminated storm water run-off from a reception basin for the corral area at the Satellite Facility upstream of this location. This is a view looking upstream from this roadway crossing on Township Road 12.
